MSIU SAFETY ALERT 01/2013

Failure of lifeboat wire fall due to corrosion that resulted in five fatalities on the Maltese registered passenger vessel *Thomson Majesty*

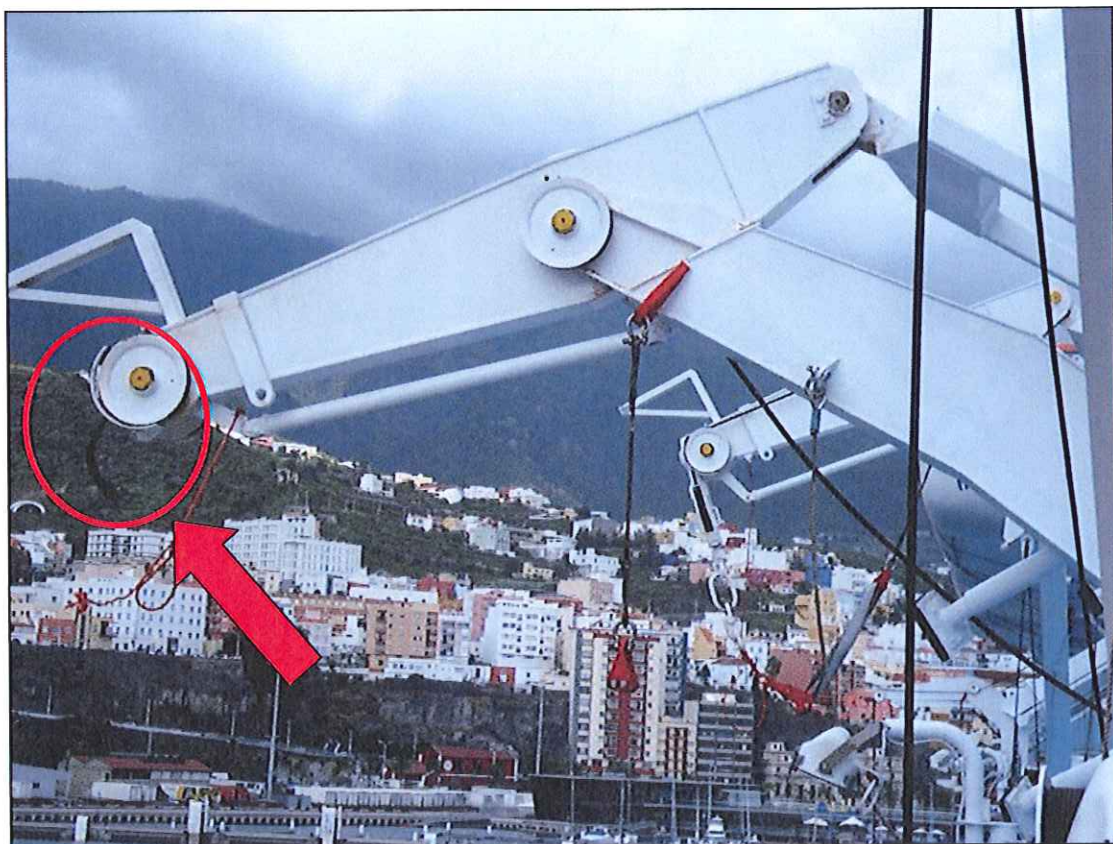
Forward Davit Arm Showing Parted Wire

The wire rope had parted approximately where it rested over the topmost sheave, when the davit was in a stowed position. The fore and aft davit's falls were replaced on 22 August 2010 and the next scheduled replacement was August 2014. The launching appliance had been dynamically tested in May 2012.

Initial results of the tests carried out on the parted ends of the wire indicate significant corrosion damage to the inner strands of the wire.

- Ensure that the falls are continuously well lubricated with an approved type of grease, particularly those areas that are difficult to inspect, where the falls pass through and around sheaves.
- Inspect regularly, frequently and thoroughly all visible parts of wire falls in order to detect general deterioration and deformation, including corrosion, abrasion, and mechanical damage.
- Review the contents of [MSC.1/Circ.1206/Rev.1](#) (Measures to Prevent Accidents with Lifeboats) and act accordingly.
