SJÖFARTSINSPEKTIONEN

**Sjöfartsverkets rapportserie B
2007-2**

The Motor Tanker VISTEN, PCKP - in collision
with the Fishing Vessel EROS, SDGK on
25 October, 2006

Our reference: 080202-06-17325/080201-06-17303
Maritime Casualty Björn Molin, +46 11 19 13 27
Investigation Division www.sjofartsverket.se
The report is also Maritime Safety Inspectorate
published on our Accidents and Near-Misses
website Accident investigation reports
Reprint permitted provided stating of source

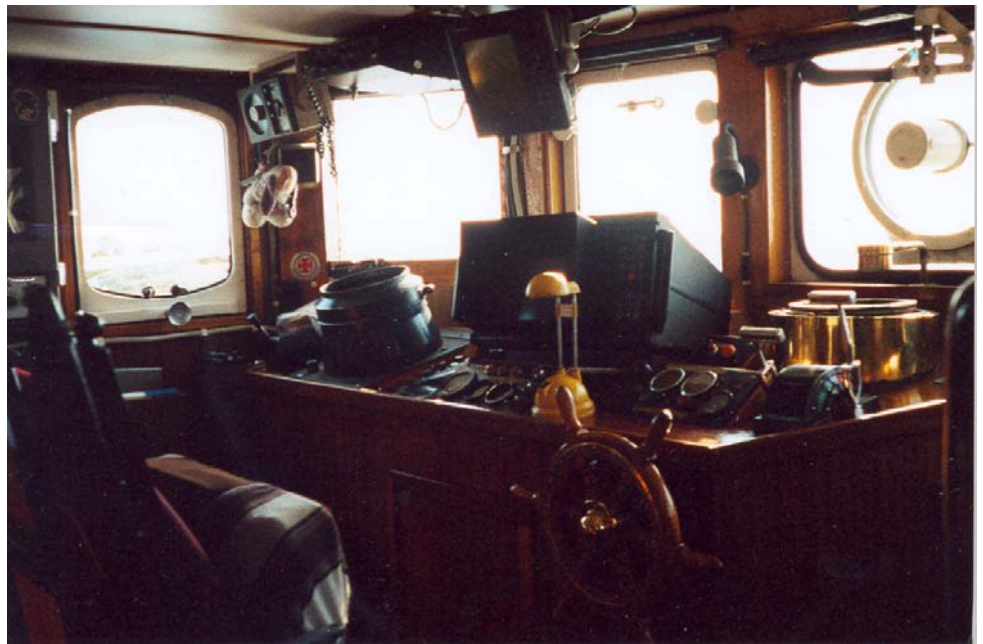
The radar unit in operation, a VHF and a GPS were placed on the port side of the centreline. A helmsman's chair was placed slightly to starboard of the centreline.

Fig. The steering desk.

The visibility from the wheel house was comparatively good, although it to a certain extent was limited by the window frame. On the port side the echo sounder was placed between the windows which made the visibility to port somewhat limited. A chart table was on the aft side to port.

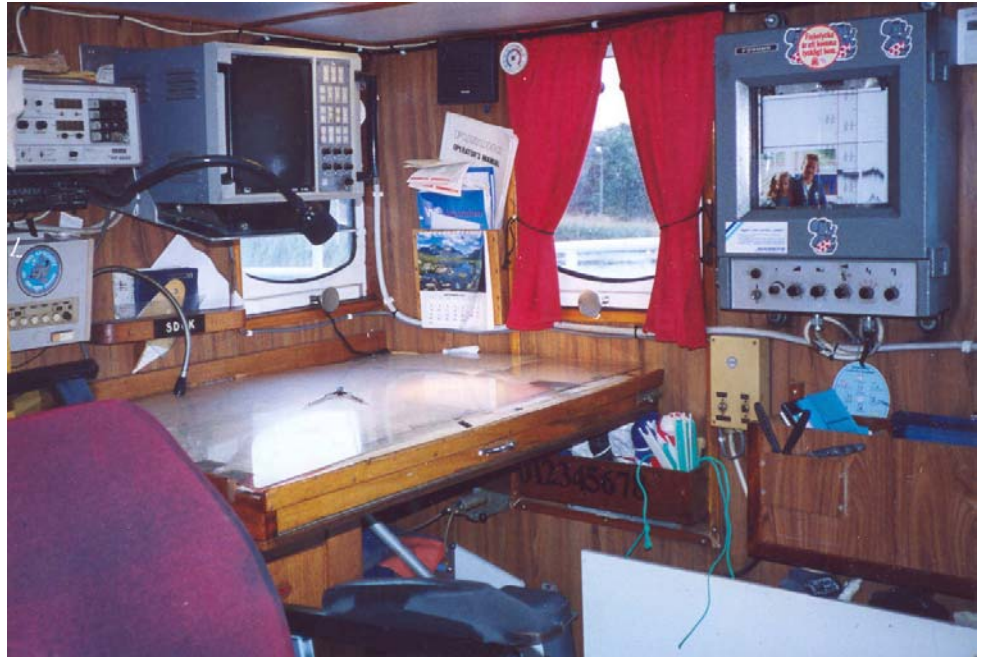
Fig. Chart table and echo sounder.

At about 1650 hours the EROS was still on course 035° and no other ships were visible in close vicinity. The master turned towards the chart table which was to port on the afterside. He then saw through the window “a blue wall” close by and he realized that they would collide with another ship. The master immediately switched to manual steering and turned to starboard. However, the turn had not started before the collision was a fact.
