**SWEDISH MARITIME
SAFETY INSPECTORATE**

**Swedish Maritime Administration
report series B 2007-1**

**Bulk Carrier SAGA SPRAY, VRWW5 - Fatal
Accident on 16 November, 2006**

Date: 2007-01-10

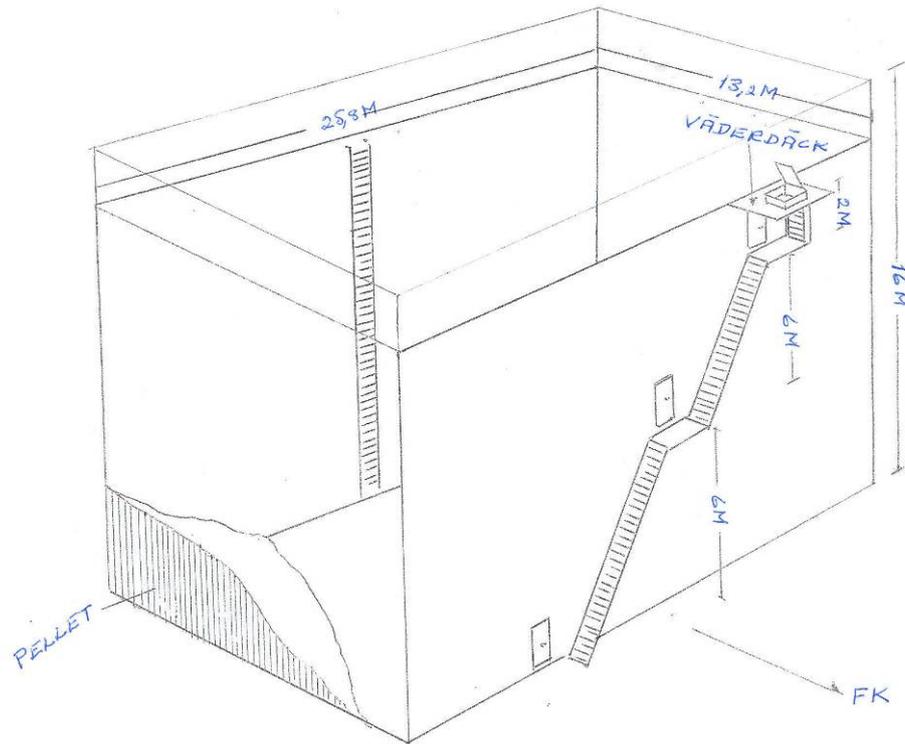
The function of the two upper doors was to give access to the cargo hold at different levels of cargo. From the access opening on weather-deck it was not possible to see the lower entrance to the cargo hold since the platforms and the staircases blocked the view.

There was no mechanical ventilation, neither in the cargo holds nor in the access trunks. Neither was there a sign or a warning on the access openings to warn of the potential hazard when entering these enclosed spaces.

After loading the wood pellets all three doors had been tightened with silver tape to make them as tight as possible. The lower door was taped up on the cargo hold side, and at the other two doors the tape was on the trunk side, which was the standard procedure.

The details of the sketch do not correspond in detail with reality.

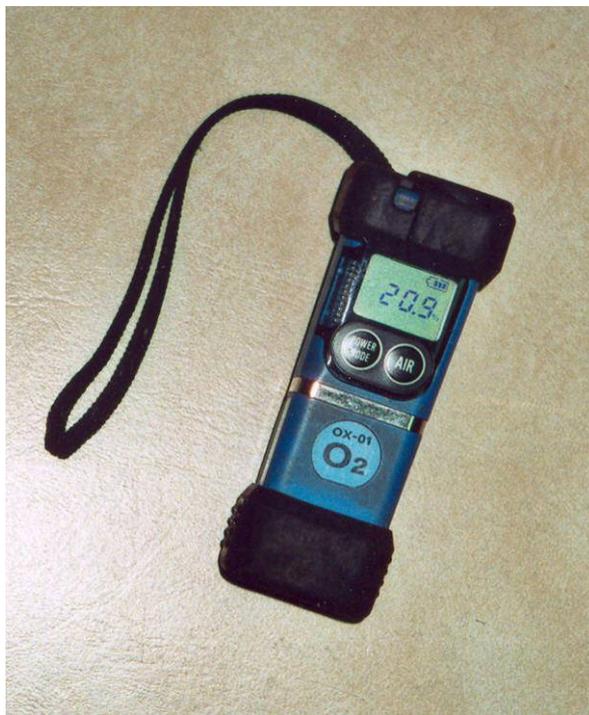
4.2 Gas meter

According to the safety manual an oxygen meter shall be used and be carried by the person who intends to enter an enclosed space.

On board there were two apparatuses for measuring the oxygen content of the air. The result of the measuring was easily read as digits in a display. The apparatuses were easy to manage and were as a rule kept in the deck office in the aft part of the deck house.
