**SWEDISH MARITIME
SAFETY INSPECTORATE**

**Swedish Maritime Administration
report series B 2008-8**

The General Cargo Ship SAGA - HMVJ6 -
Grounding on June 20, 2008

Date: 14 August, 2008

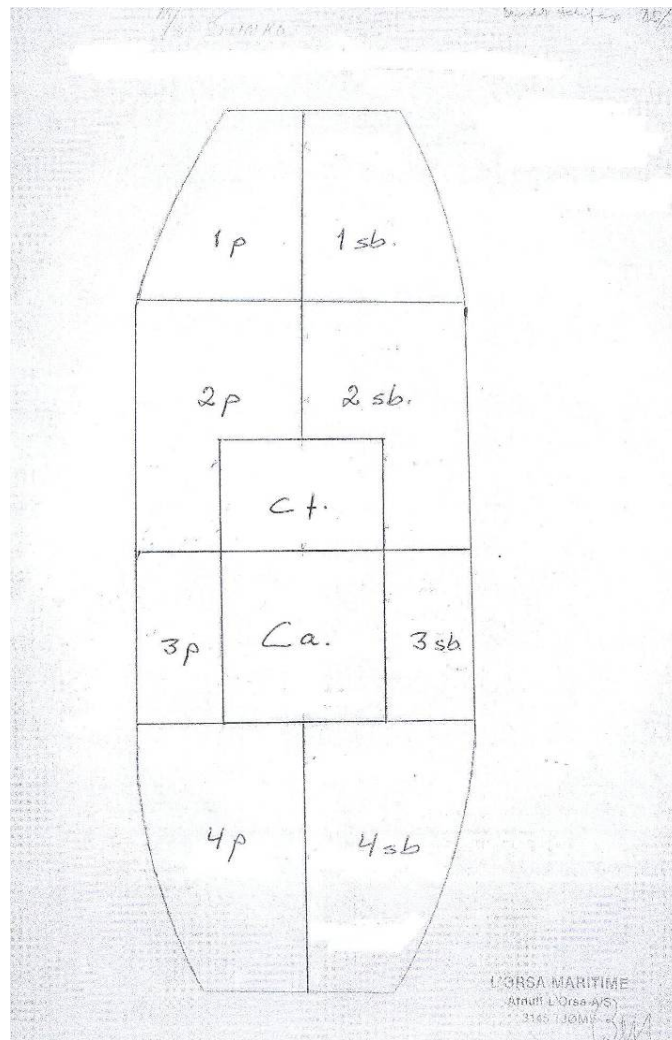
Picture. The tank plan of the SAGA

Under the whole cargo space was a double bottom, which was divided into double bottom tanks. No. 1 starboard and port held 36 m^3 each, No. 2 starboard and port 34.9 m^3 each, No. 3 starboard and port 19.6 m^3 each and No. 4 starboard and port 38.5 m^3 each. All these tanks, as well as the forepeak tank with a capacity of 11.9 m^3 , were intended for ballast water.

The chief engineer had just opened the valve to No. 4 starboard ballast tank when he felt the grounding. In his excitement he then forgot to open also the valve to No. 4 port ballast tank, which made the SAGA get an increasing list to starboard.

The first touch to the ground was thus ahead of L/2 in level with No. 2 ballast tank to starboard, and then just aft of L/2 in level with No. 3 ballast tank to starboard.

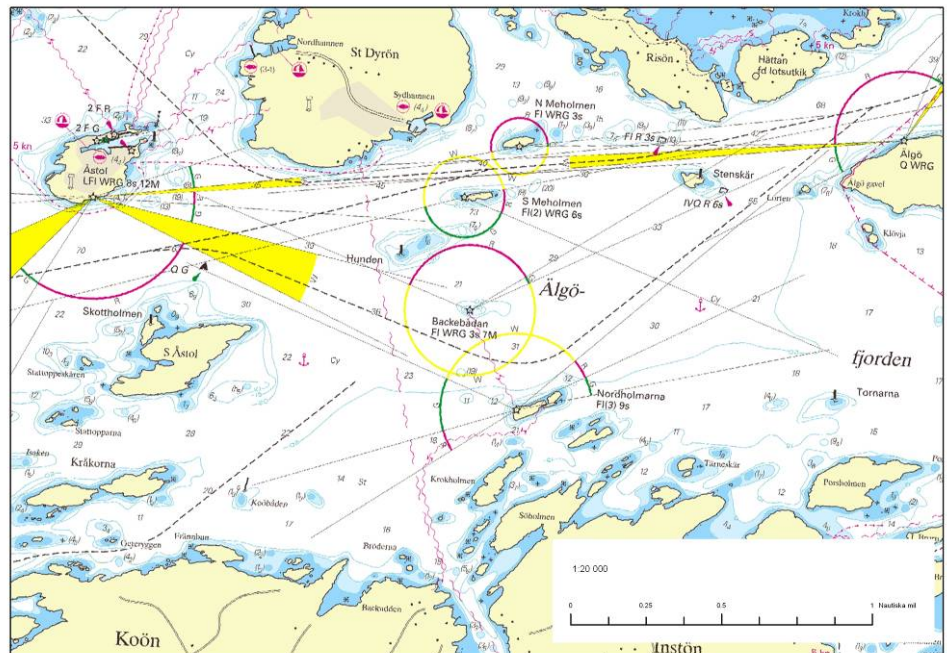
2.6 The fairway (see extract from chart)

There was also the possibility to pass north of Backebådan, between the lighthouse and the cairn Hunden. This is the passage that the SAGA's master chose, and which is actually no public fairway.

The distance between the lighthouse Backebådan and the beacon Hunden was 2.7 cables (1 cable = 185 metres).

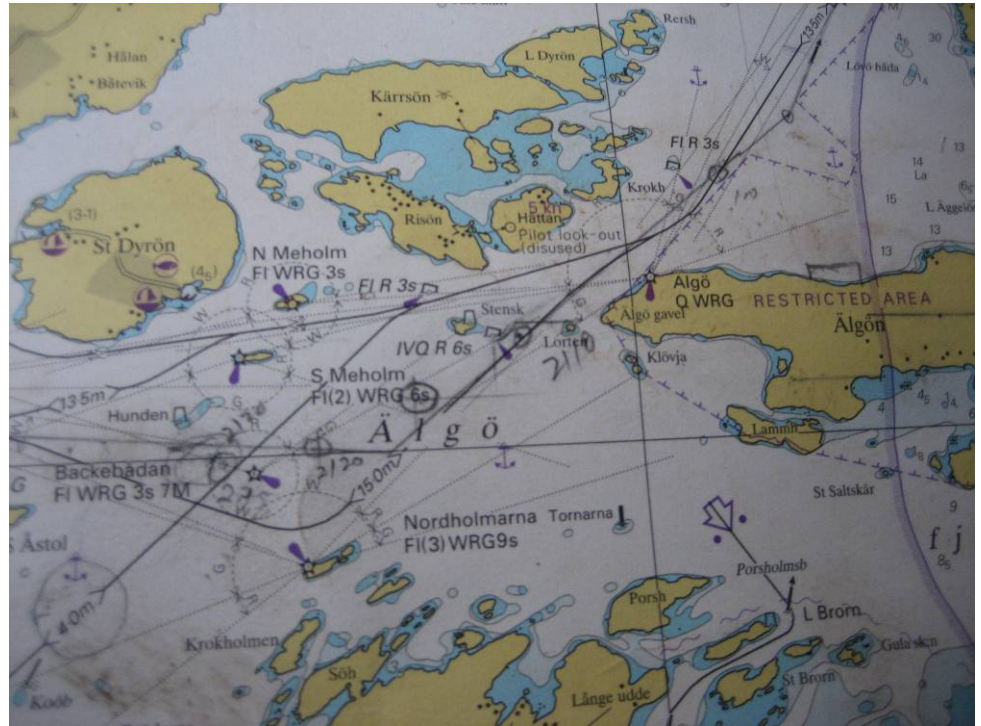
Picture. The chart in question with marked positions.

A touch to the bottom at Hunden would be possible at a course over ground of 295° , i.e. a drift to north of 14° .

As appears from the chart above, photographed on board the ship, a position (at 2130 hours) had been marked about 140 metres westnorthwest of Backebådan. If this position is correct, a course towards the point assumed above would be 284° and the course over ground for a touch to the bottom at Hunden would be 305° , which implies a drift to the north of 25° .
