**Chemical Tanker MARIA M
IMO No. 9301885 – IBSK
Grounding on 14 July, 2009**

Date: 15 March, 2010
Maritime Department
Maritime Investigation Unit

Our reference: 060503-TSS-2009-3752
Maritime Investigation Unit Richard Blomstrand +46 11 19 15 43
richard.blomstrand@transportstyrelsen.se
Sten Anderson +46 11 19 12 69
sten.anderson@transportstyrelsen.se

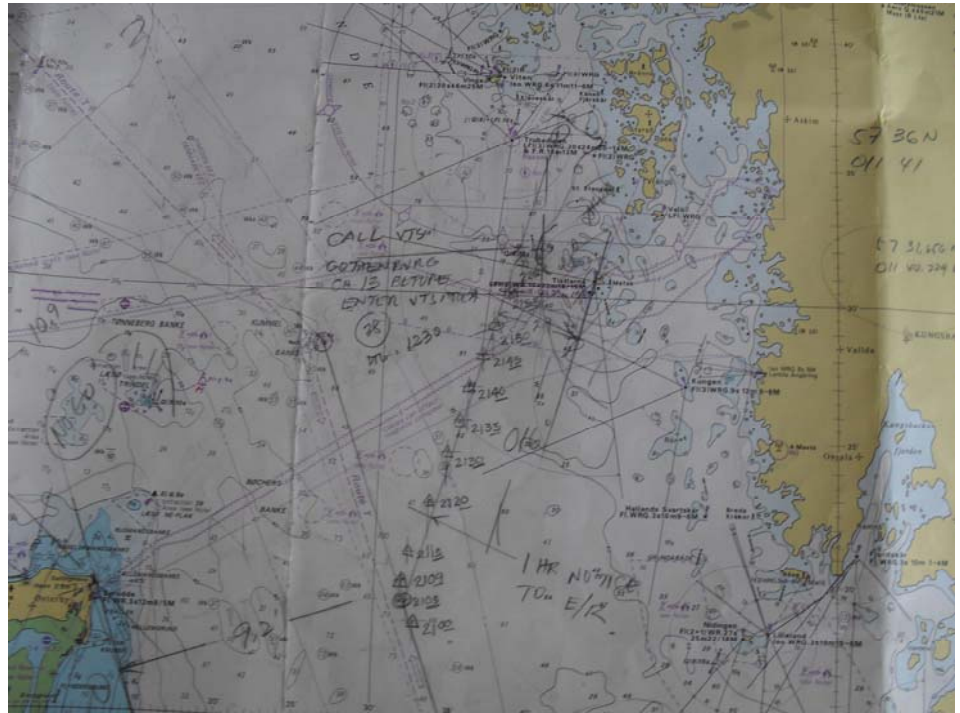
Picture 5 – The chart

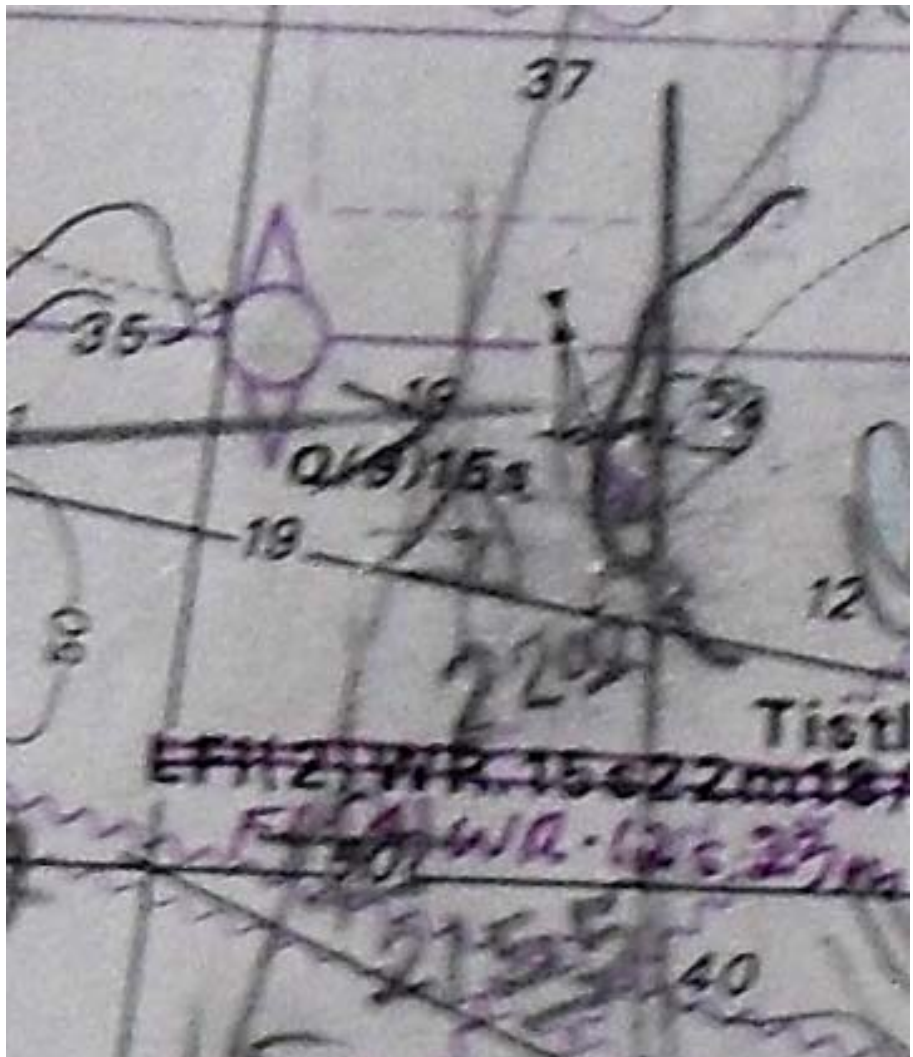
At about 2202 hours the OOW noted the last position in the chart before the grounding. The crew had carefully marked the Vanguard's ground with a pencil in the chart as an area to be avoided (see picture 6).

Picture 6 – The BA chart showing the marked area.

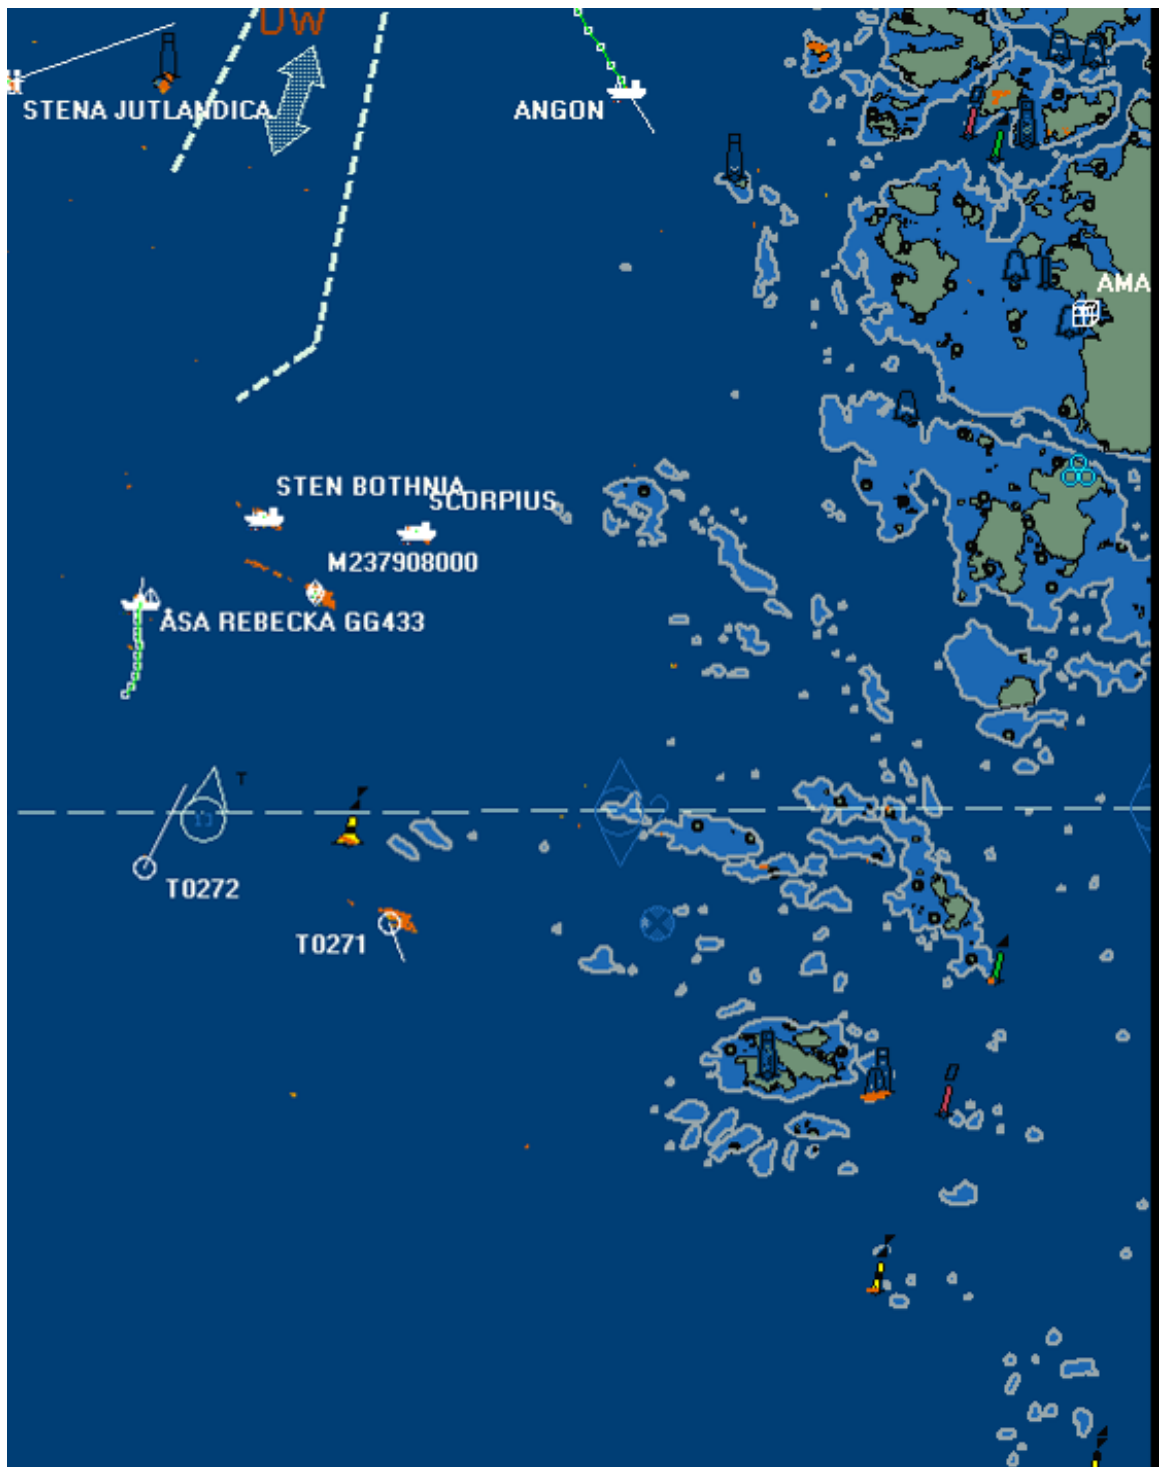
At about 2206 hours the VTS starts plotting the MARIA M on their radar screens (see picture 7).

Picture 7 – VTS WC starts plotting the MARIA M at 2206 hours (T0271)

The transverse, broken line in the centre of the picture shows the south border of VTS Gothenburg (part of VTS WC).

The Maritime Department of the Swedish Transport Agency recommend the Swedish Maritime Administration to consider entering in the VTS-routines that all ships plotted on the VTS operator's radar screen (i.e. those ships that the operator actively has acknowledged) should be regarded as being inside the VTS area, no matter where they are.

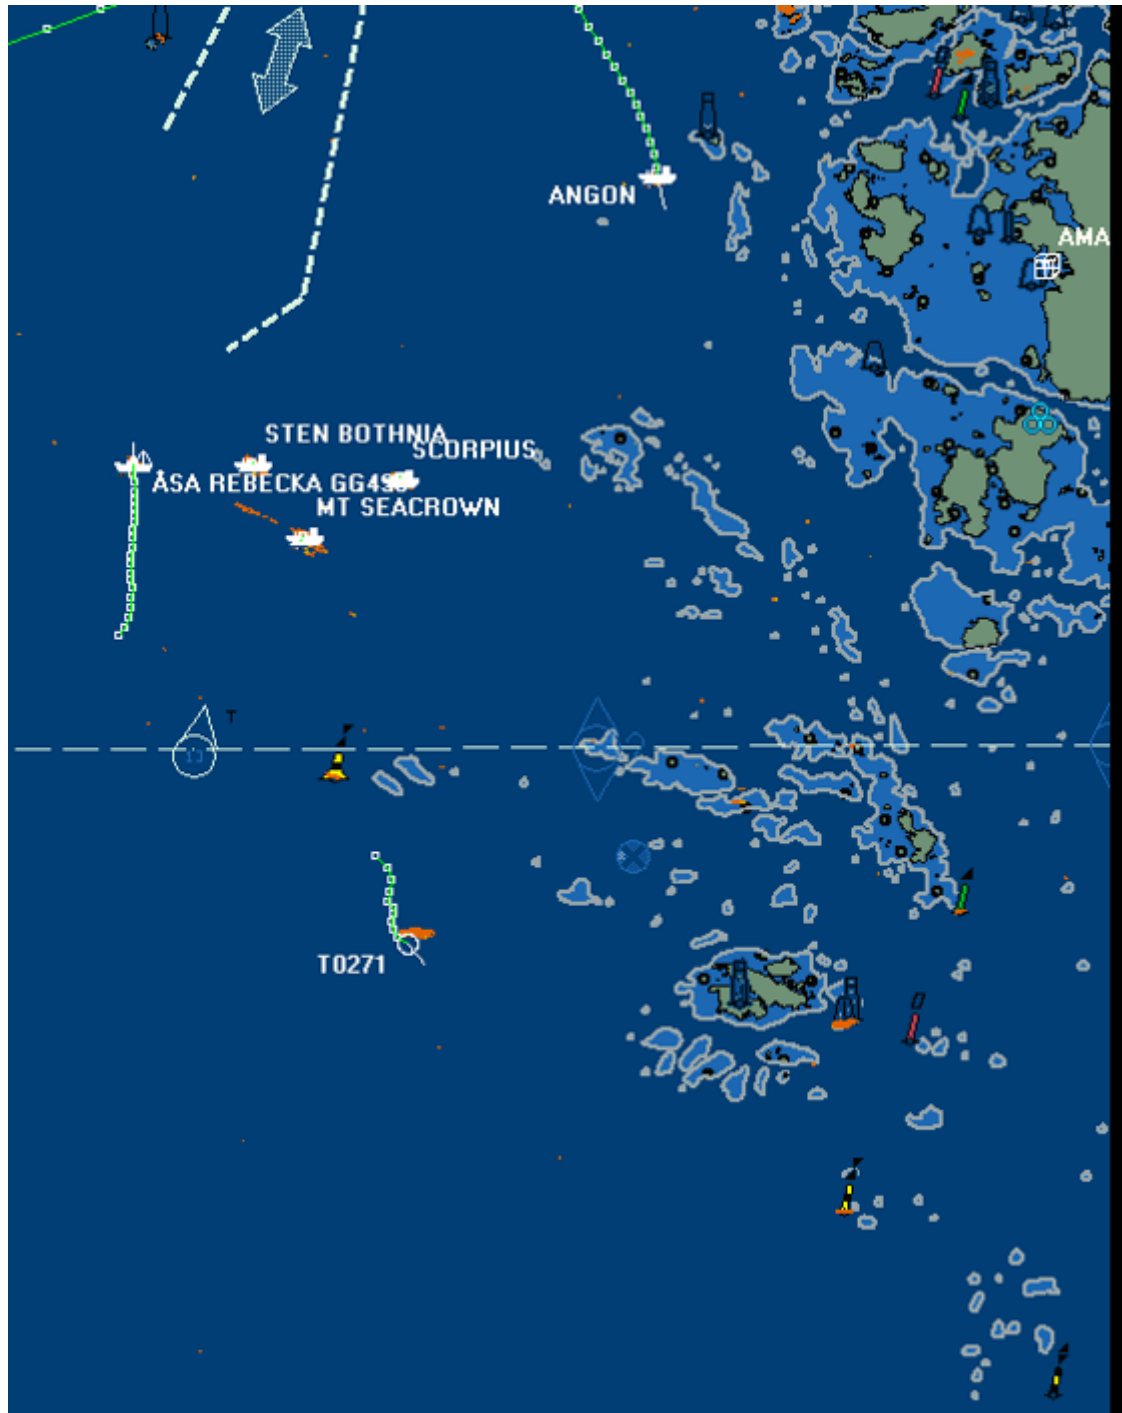
Picture 8 – Screen dump from at about 2216 hours (T0271)

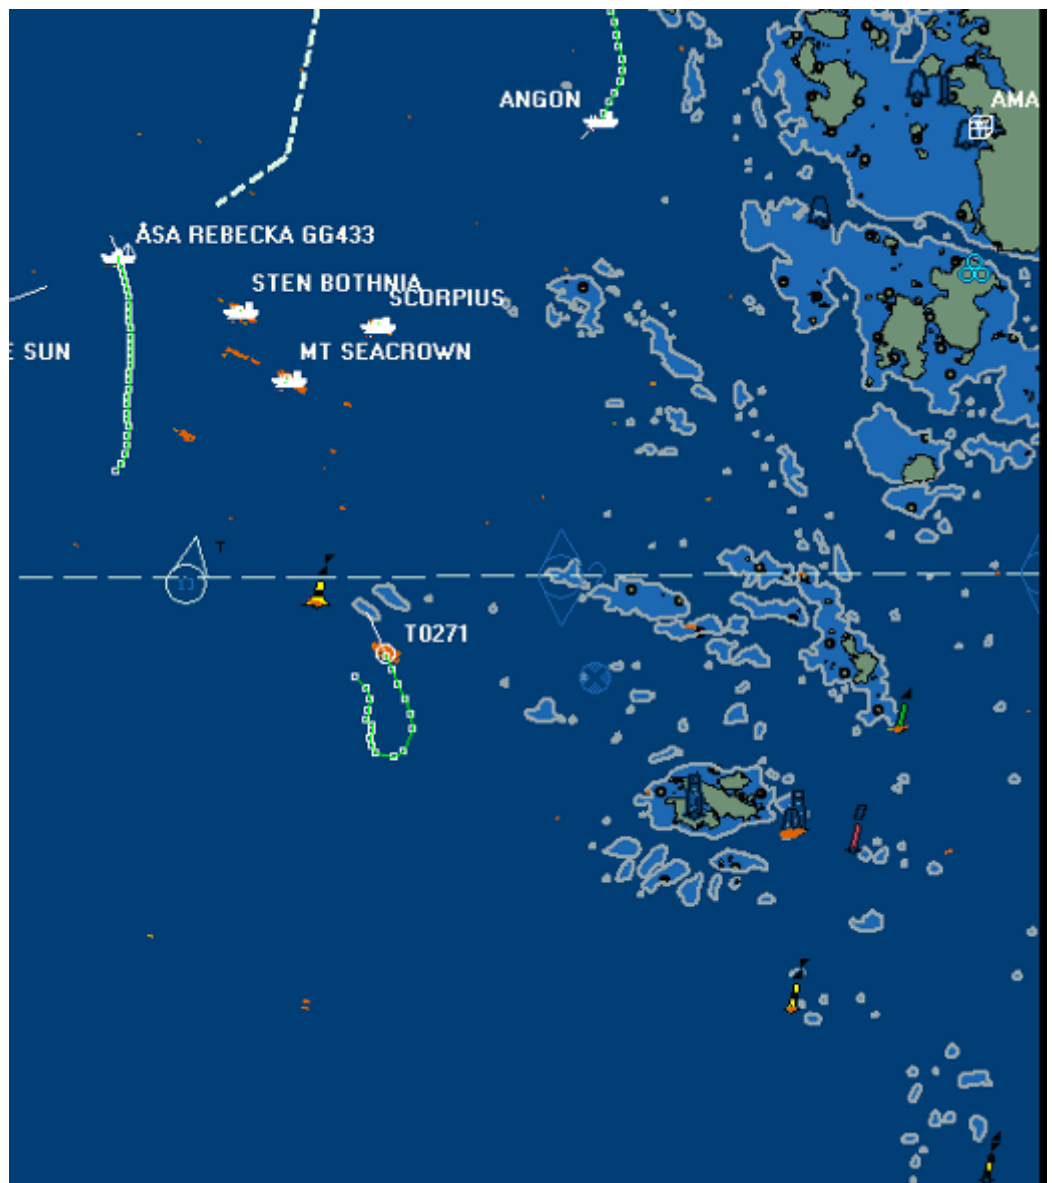
Picture 9 – Screen dump from the VTS at 2224 hours (T0271)

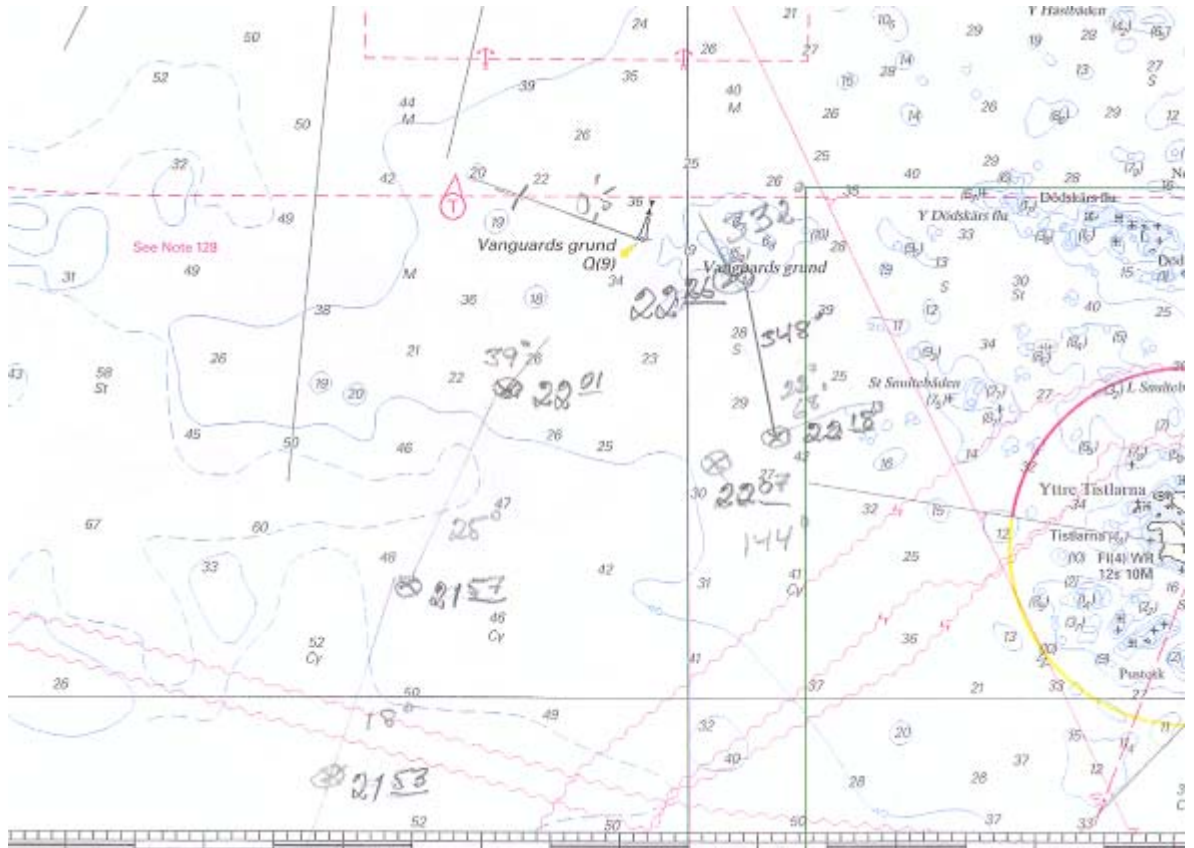
Four minutes later, at 2226 hours, the *MARIA M* run aground on Vanguards ground in position N 57°31'.63 E 011°40'.30. The course over ground at that moment was 332° and the speed 6.7 knots.

Picture 10 – Positions and courses noted by the investigator in Swedish chart No. 931. In the centre of the upper part of the picture anchoring area "B" shows. Anchoring area "C" is located 3,8 M north of Vanguards ground.

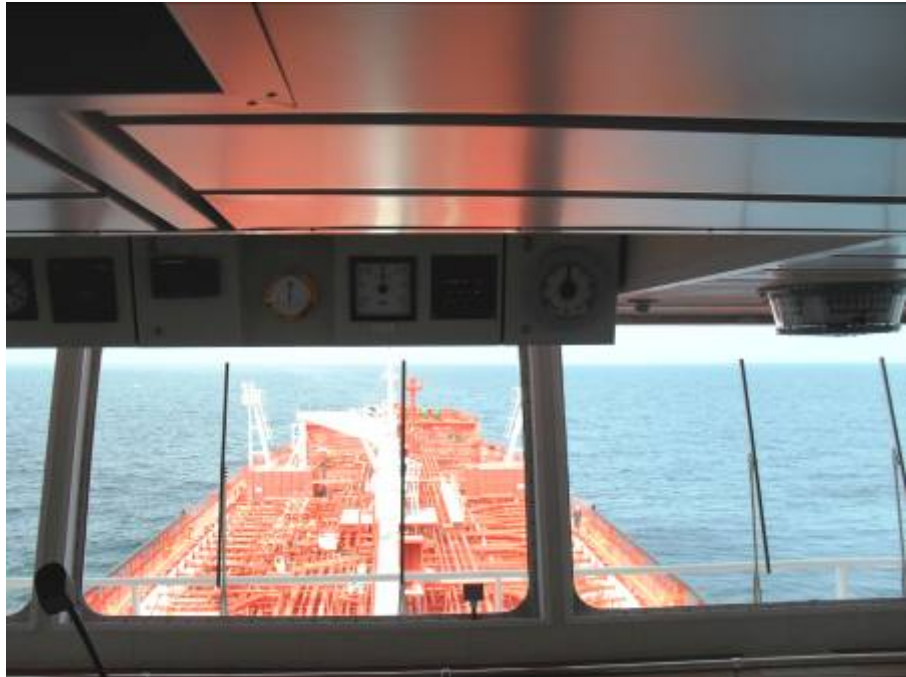
The two indicators for rudder position and turning rate (see picture 11) were located at a distance of about one metre from one another under deck on the front edge of the bridge. The turning rate was shown by an arrow which pointed to starboard at turns to starboard, and to port at turns to port. A quicker turning rate was shown by a greater deflection of the arrow. The turning rate indicator could thus show turning to port although the rudder was to starboard, and vice versa.

Picture 11 – View over the front edge of the bridge with the indicators showing rudder position and turning rate.

The master discussed the indicator with the third officer as well as the chief officer. It seems as if he confused rudder position and turning rate, since from the VDR sound recording one gets a definite impression that the master interpreted the deflection on the turning rate indicator as showing the rudder position.

This indicates that the master was just unfamiliar with the instruments, which gives a possible explanation to the strange manoeuvring.

The Maritime Department of the Swedish Transport Agency recommend ship owners, in accordance with the ISM Code part A 6.3, to ascertain that routines are followed when it comes to checking that new signed-on crew fully understand and are familiar with their place of work and their tasks.
