**SWEDISH MARITIME
SAFETY INSPECTORATE**

**Swedish Maritime Administration
report series B 2008-8**

The General Cargo Ship SAGA - HMVJ6 -
Grounding on June 20, 2008

Date: 14 August, 2008

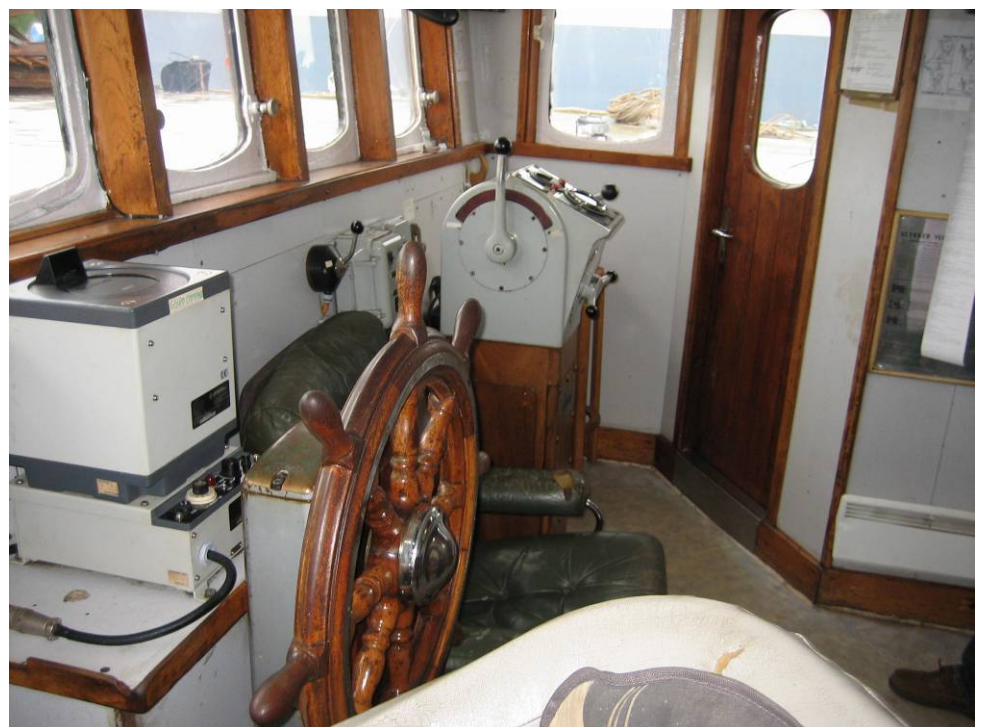
Picture SAGA's bridge with the engine control in the background

On the far end on the port side a second-hand radar of make Kodon MD 3840 was fixed to a bench. The master said that it was in very good working order. Close by, on the floor, was an old radar of make JRC, which was not in use.

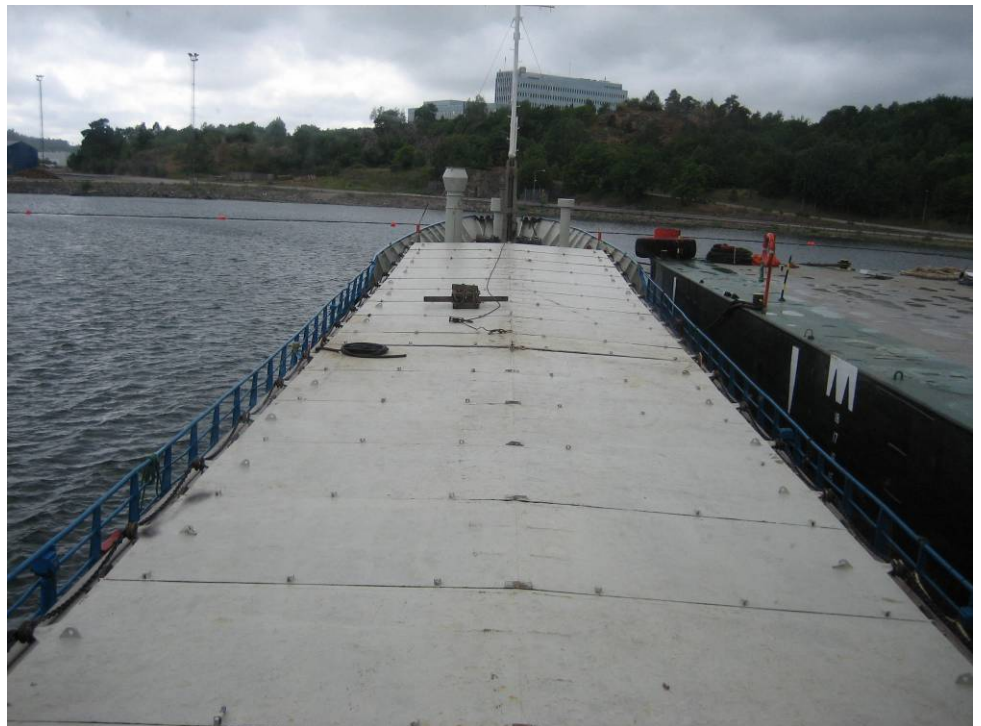
Picture View from SAGA's bridge
