**Chemical Tanker MARIA M
IMO No. 9301885 – IBSK
Grounding on 14 July, 2009**

Date: 15 March, 2010
Maritime Department
Maritime Investigation Unit

Our reference: 060503-TSS-2009-3752
Maritime Investigation Unit Richard Blomstrand +46 11 19 15 43
richard.blomstrand@transportstyrelsen.se
Sten Anderson +46 11 19 12 69
sten.anderson@transportstyrelsen.se

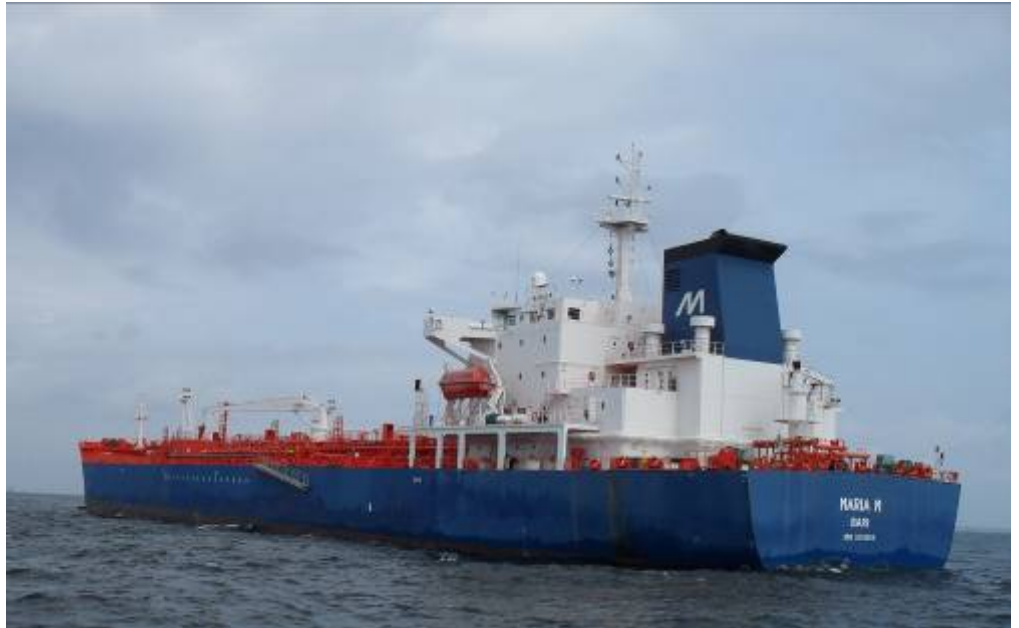
Picture 1

The *MARIA M* was built at SLS Shipbuilding Co. Ltd in Tongyeong in the Republic of Korea in 2006 for Italian buyers. The ship flew the Italian flag but was under Greek management.

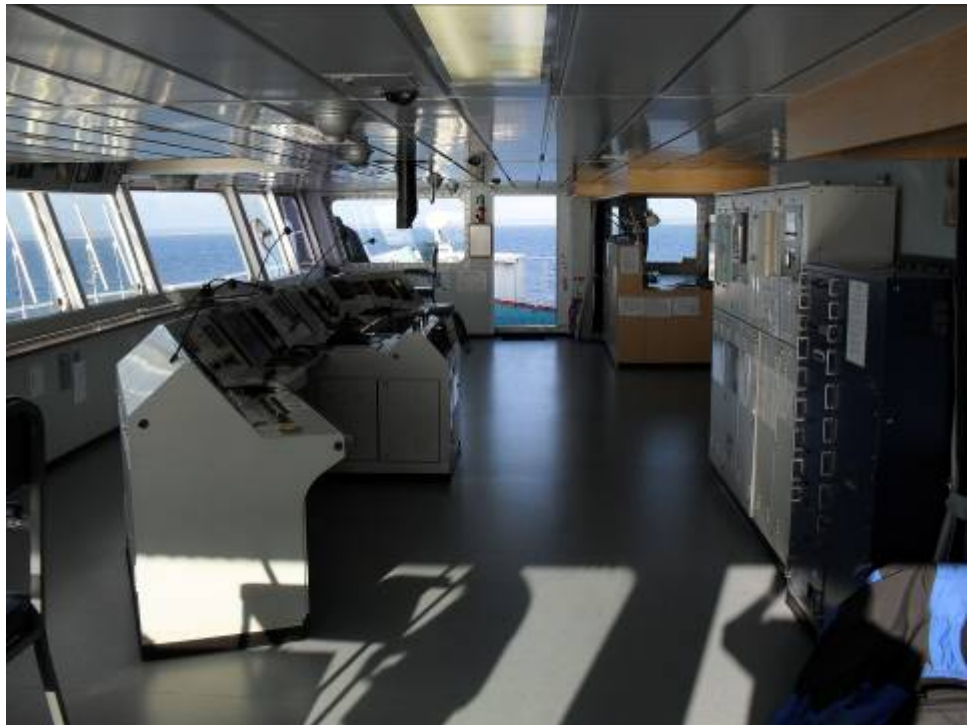
Picture 2

In relation to the occurrence the most interesting equipment on the bridge was two radar units of make JRC type JMA 9932-SA and type JMA 9922-6 XA. The gyro compass was a Yokogawa type CMZ 700S, the

The AIS of the ship was out of order since 5 July. By the equipment other ships could be traced but there was no transmission from the MARIA M. Repair was scheduled when the ship was loading in Ventspils, but according to the shipowner no technician was available for the repairs.

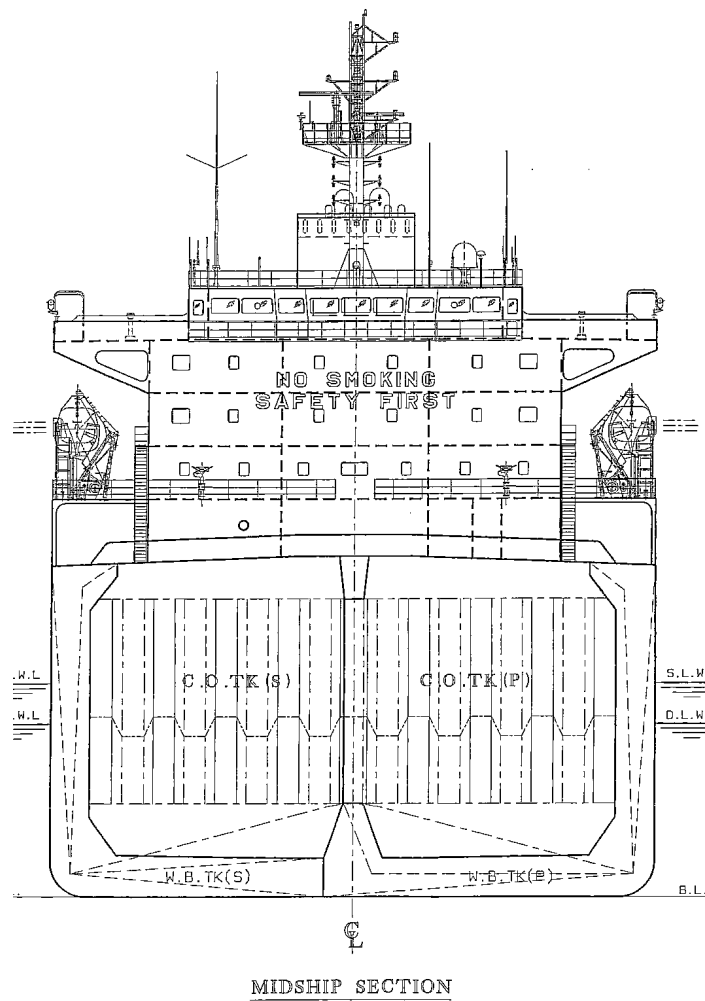
Picture 3

The MARIA M was a so called double skin ship with six ballast tanks stretching from the centre line to the bilge and up to deck; thus all cargo tanks were enclosed by ballast tanks on the outer side and in the bottom (see picture 3). In the very forward part of the ship was the forepeak and astern of the engine room the afterpeak.

At diversings while the ship was still aground it was found that No. 1 starboard side tank had got a hole, about 3 x 1.5 m. A crack in the forepeak of about 1.5 m was also noted.

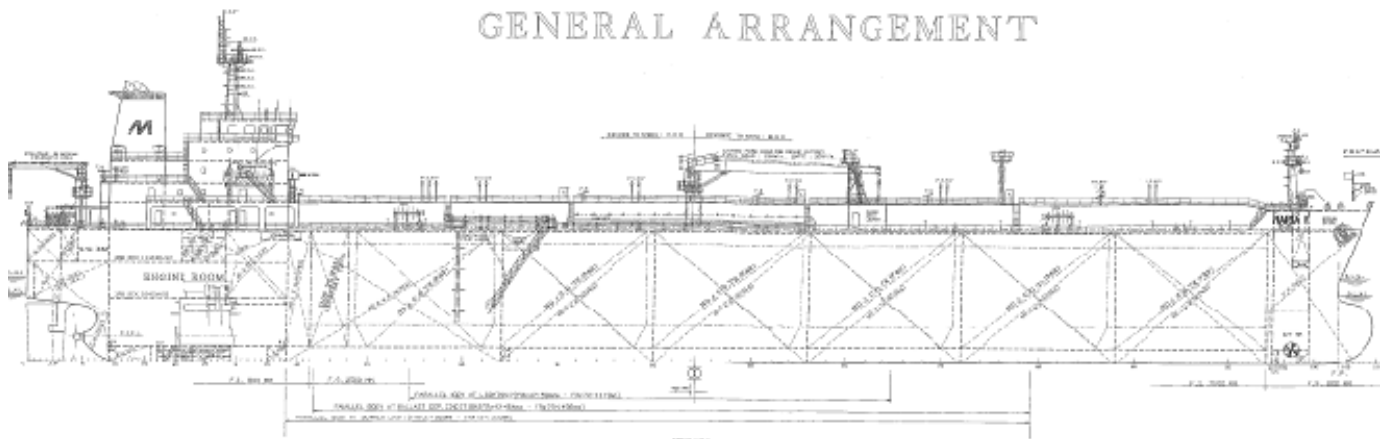
Picture 4

At the grounding the *MARIA M* had about 260 MT HFO and 30 MT MDO, in addition to the cargo. There were also about 60 MT lubricating oil on board, placed in various tanks in the vicinity of the engine room.
